DIM ESEE-2 innovative workshop

Dubrovnik 20-22nd of Oct. 2021

Case studies: exploration of flooded underground spaces. the UNEXMIN-UNEXUP story

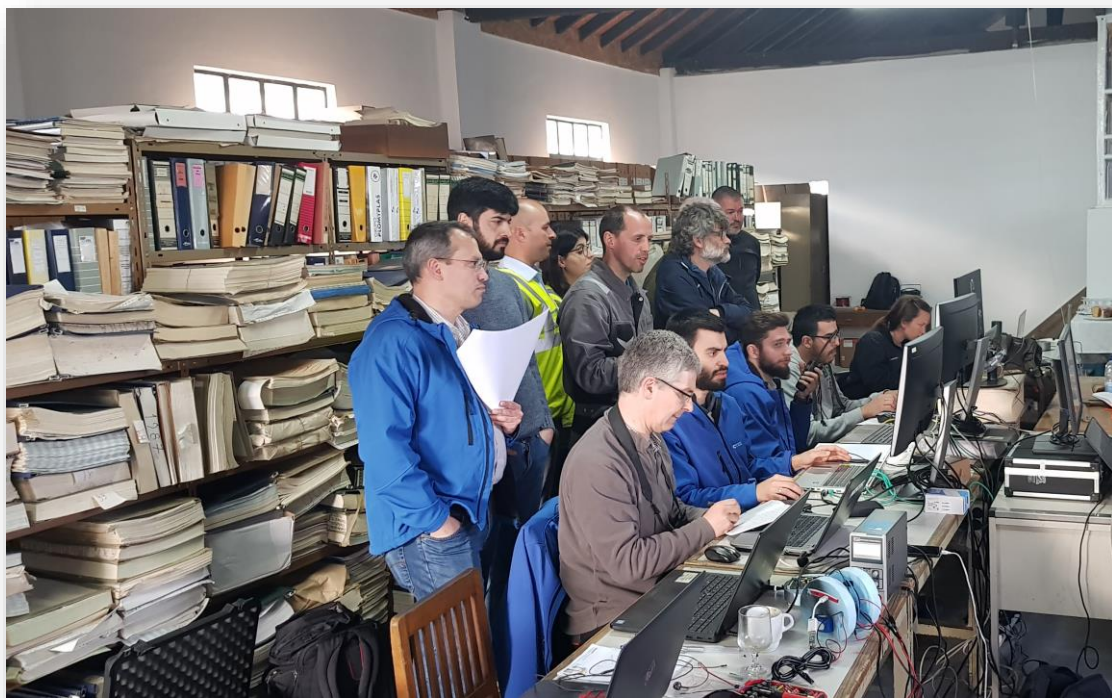
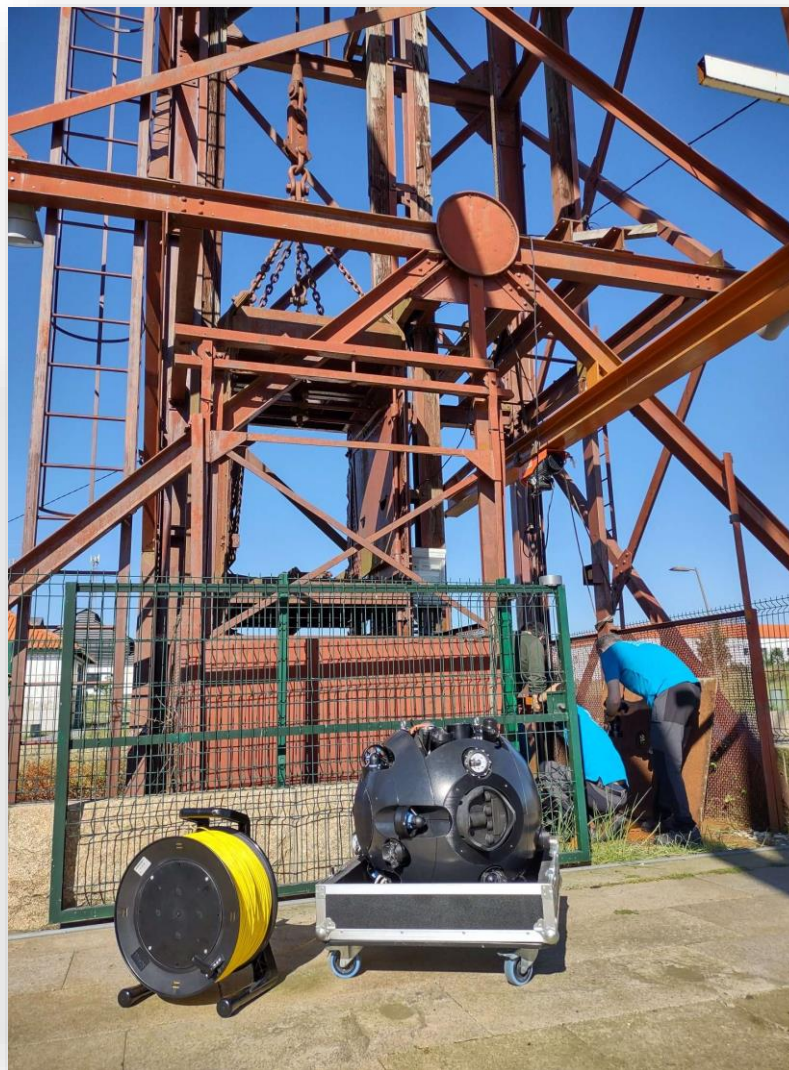
Mapping: from sonar + SLS (+DVL) to octomap

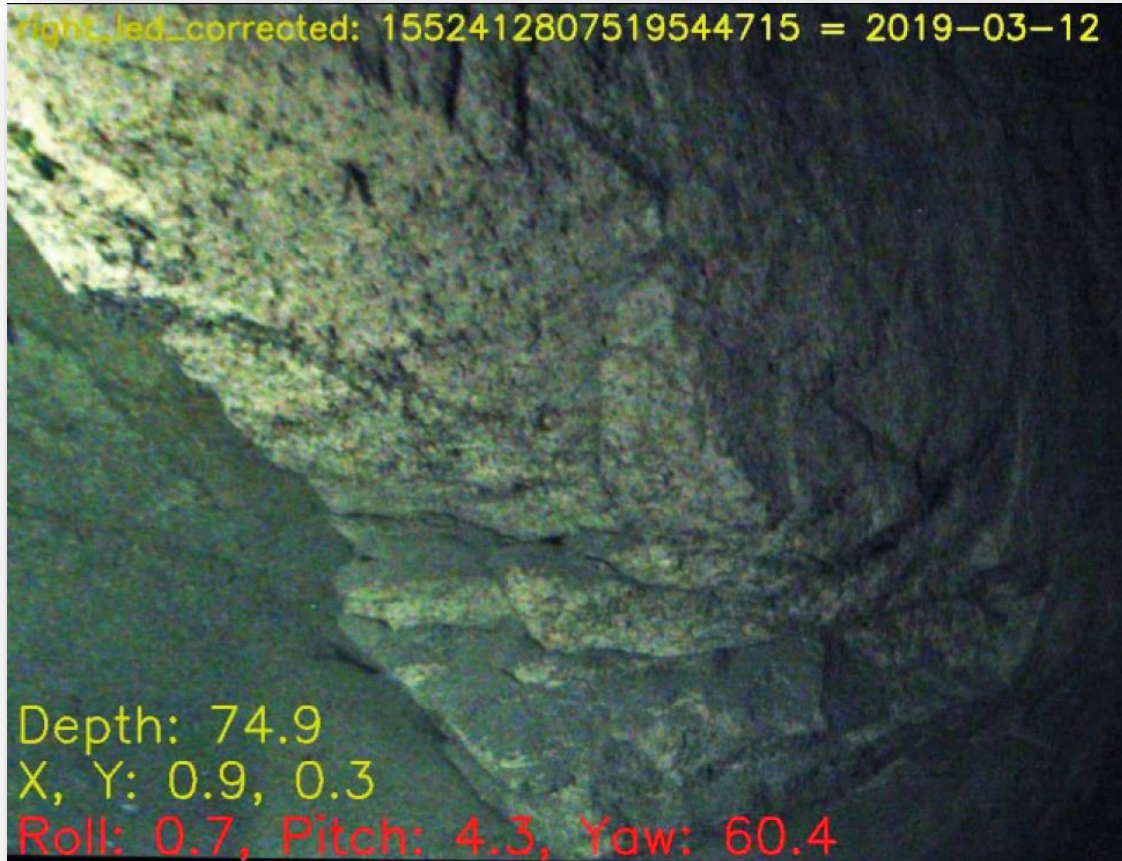
Granite with black veinlets (possibly pichblende)

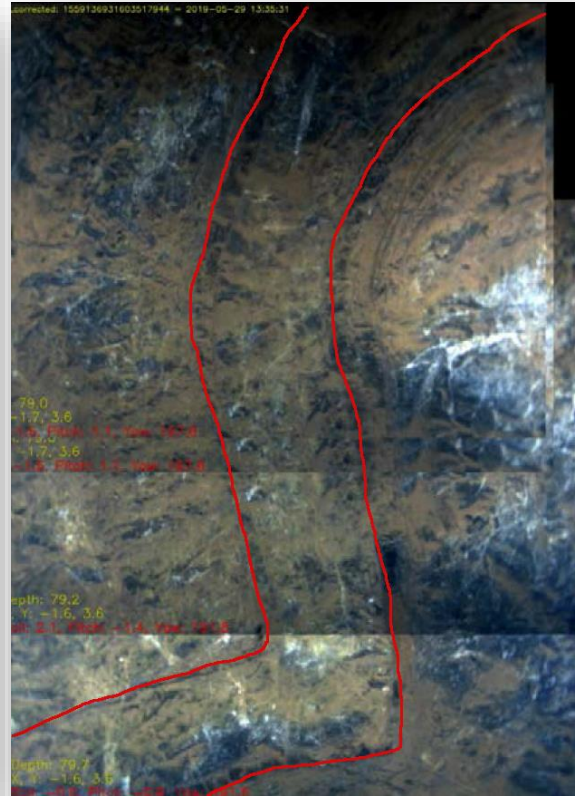
Syncline with calcitized tension cracks, winding shaft (-46-48 m)

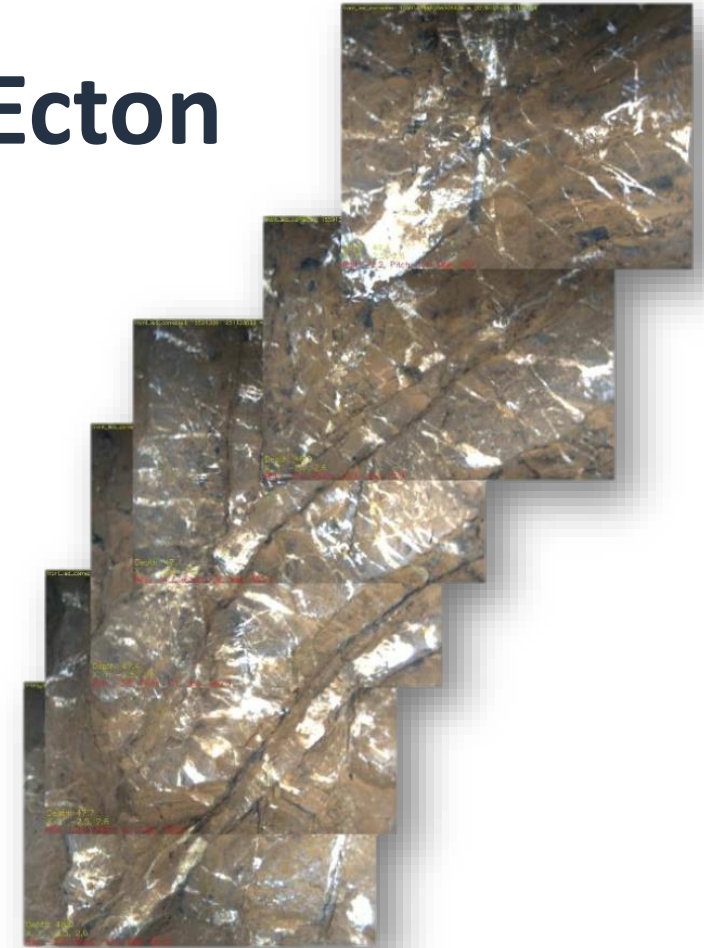
Ecton mine, geology of the winding shaft 0 m to -85 m

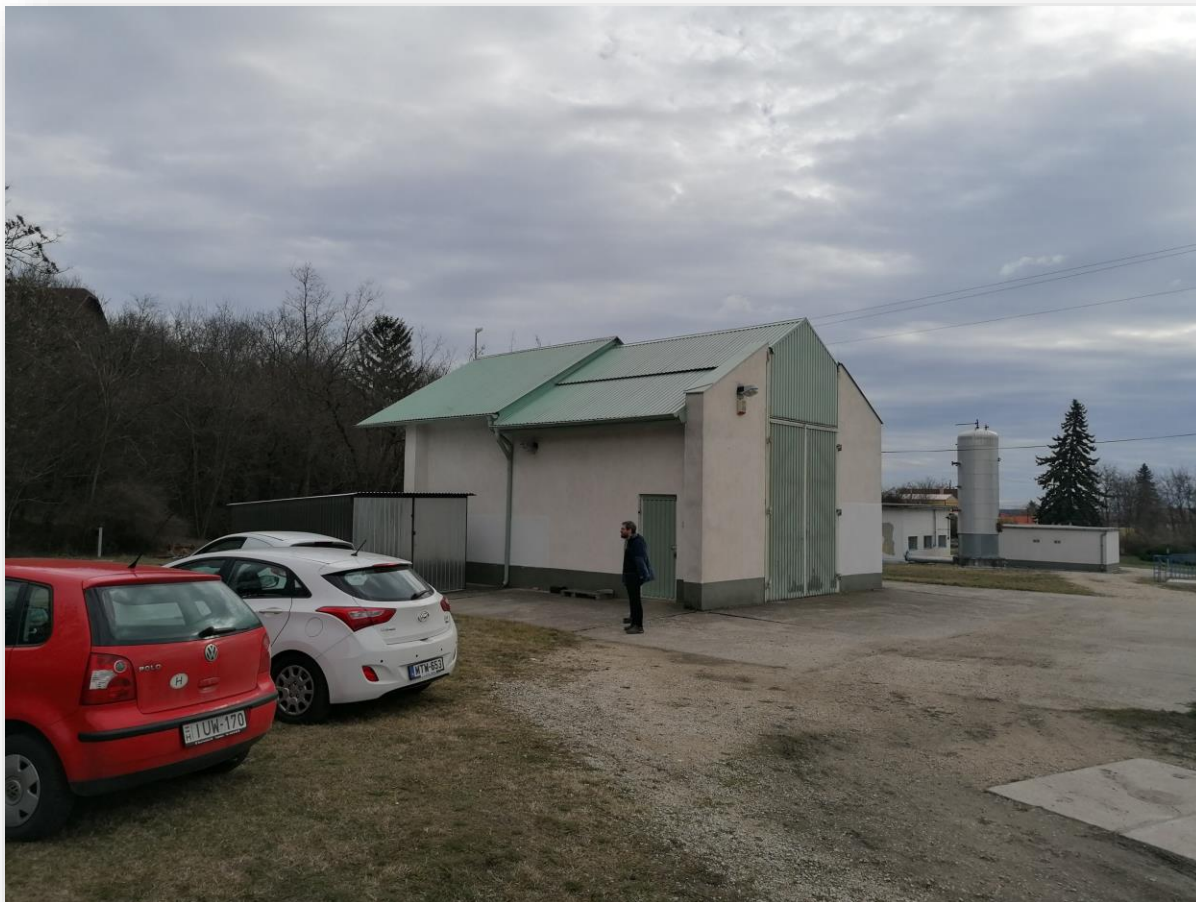
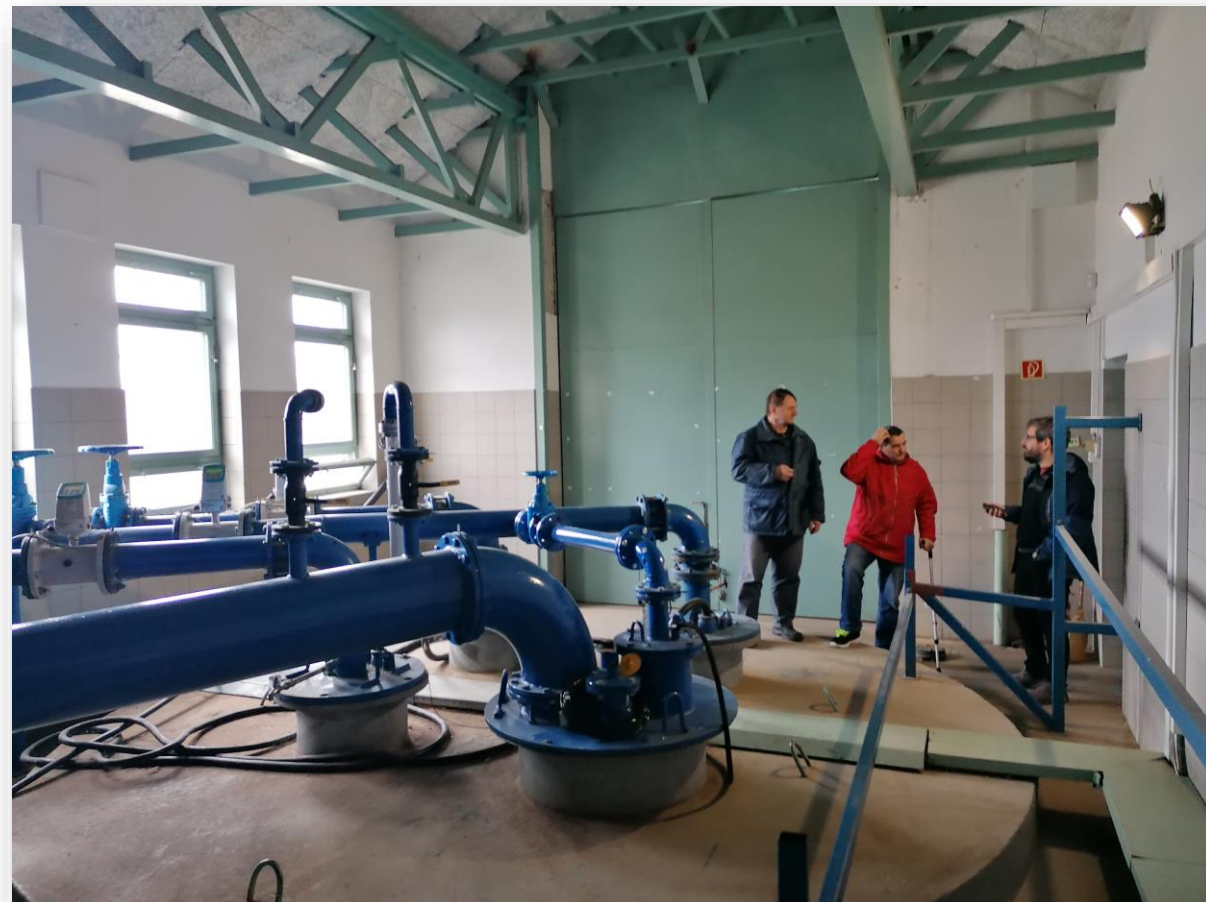
Sterilization and referencing of UX-1Neo
